Coginchaug River Watershed Based Plan

Prepared by the USDA – Natural Resources Conservation Service
July 2008

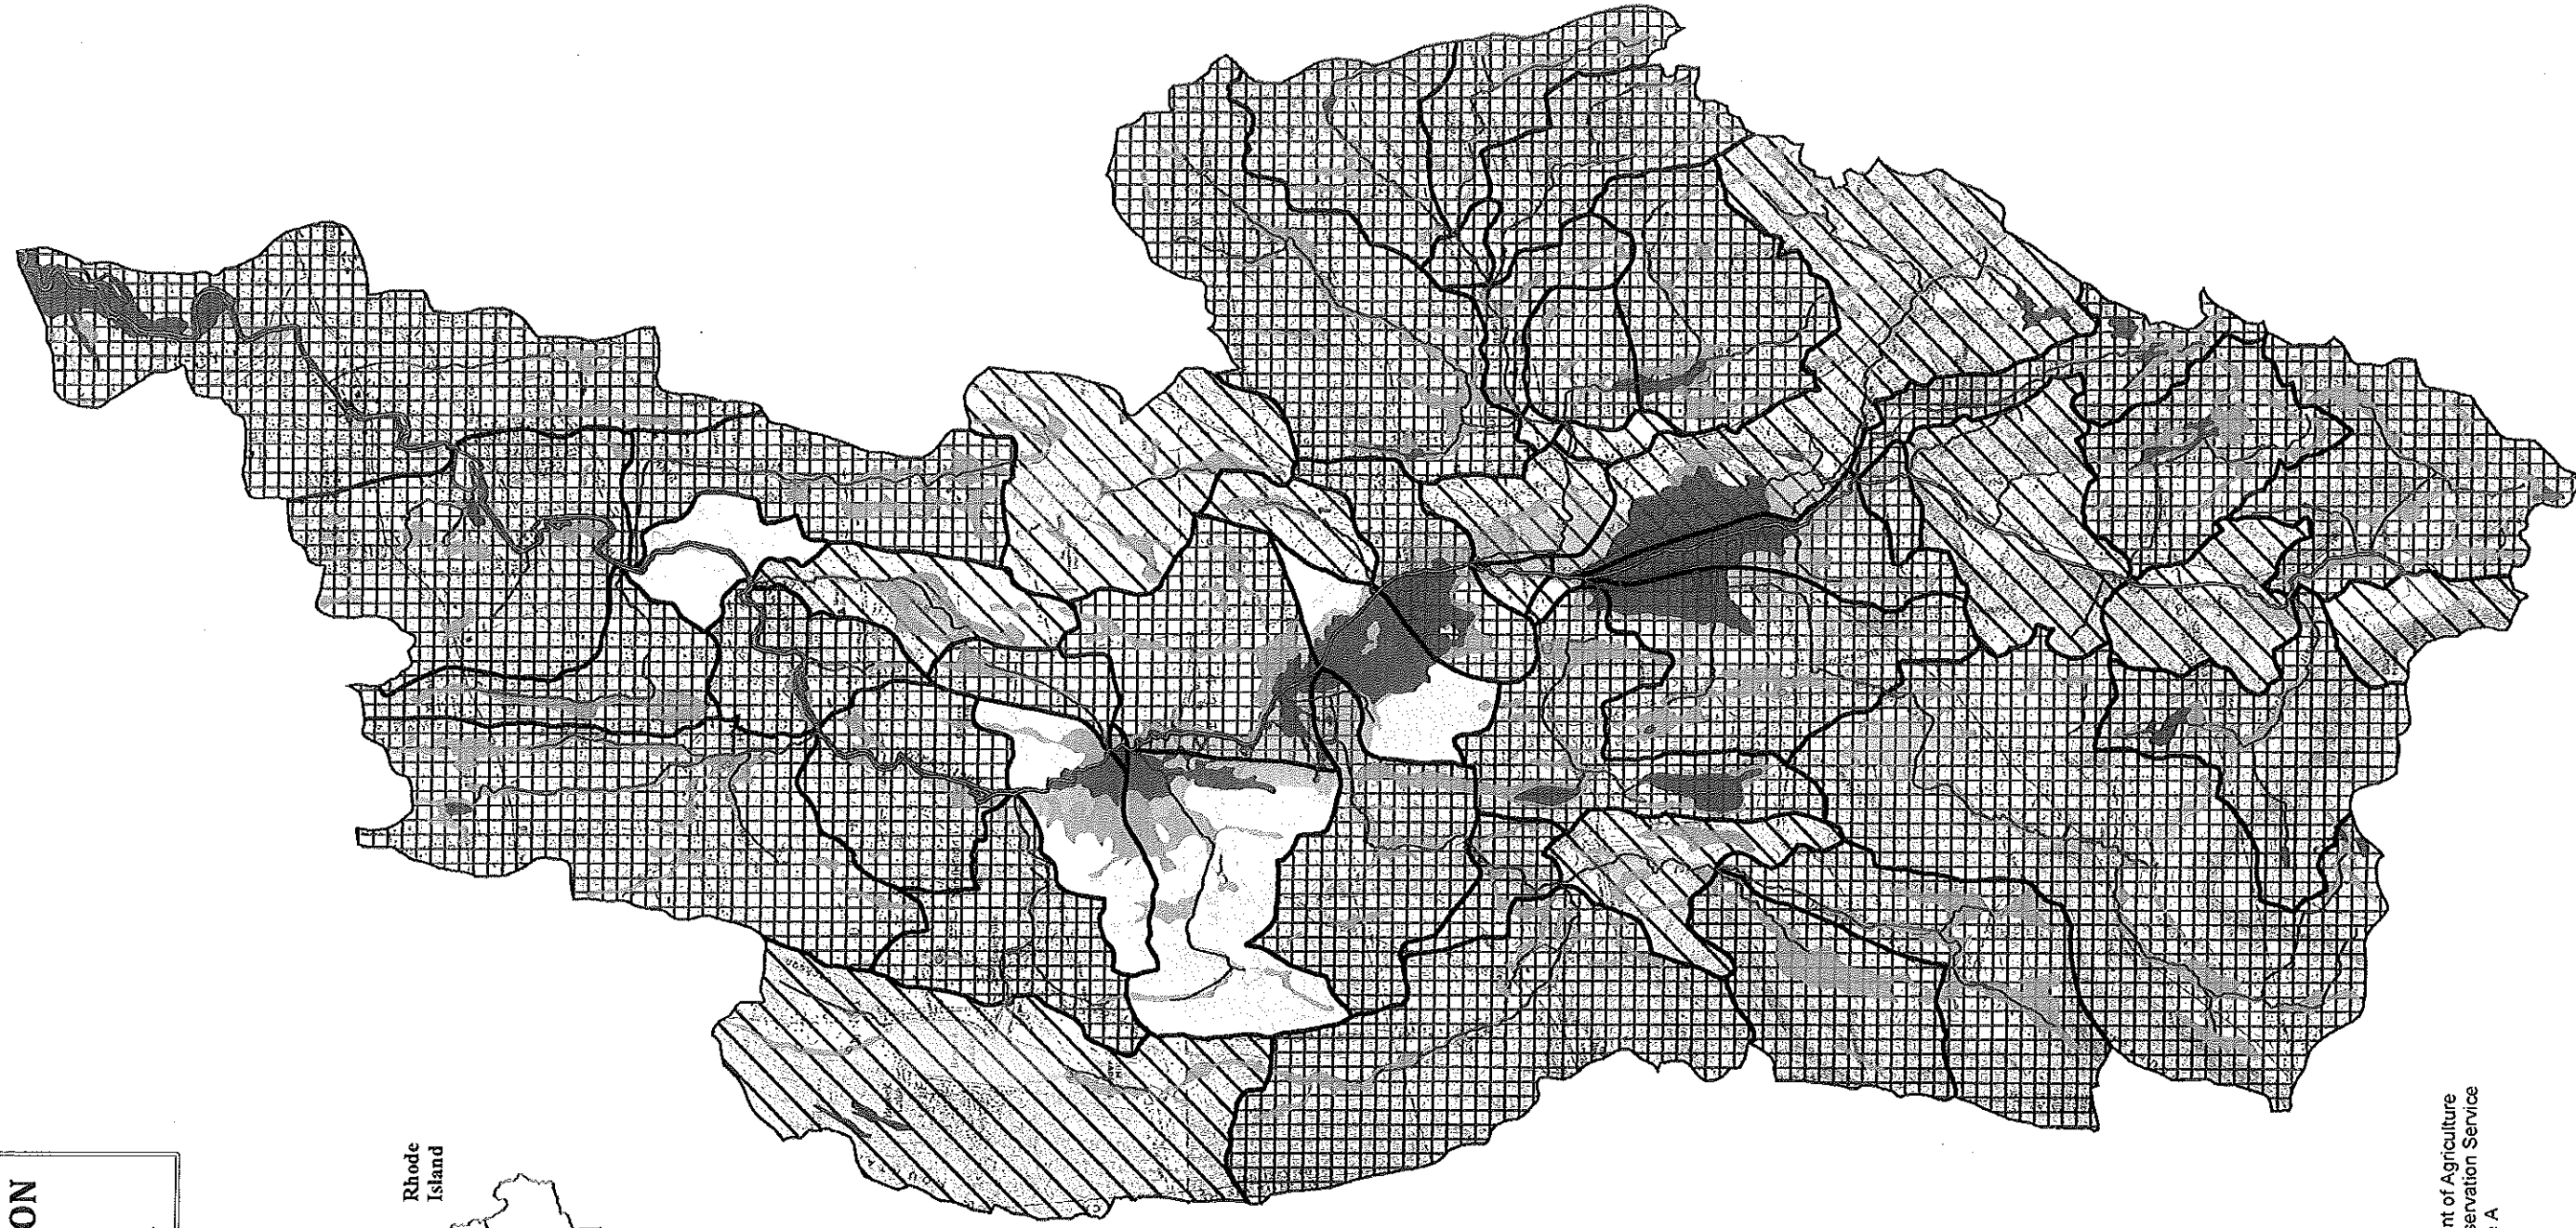
**MAP 9: WETLAND EVALUATION
INFLOW RATING
Coginchaug River Watershed**

Watershed Inflow Rating

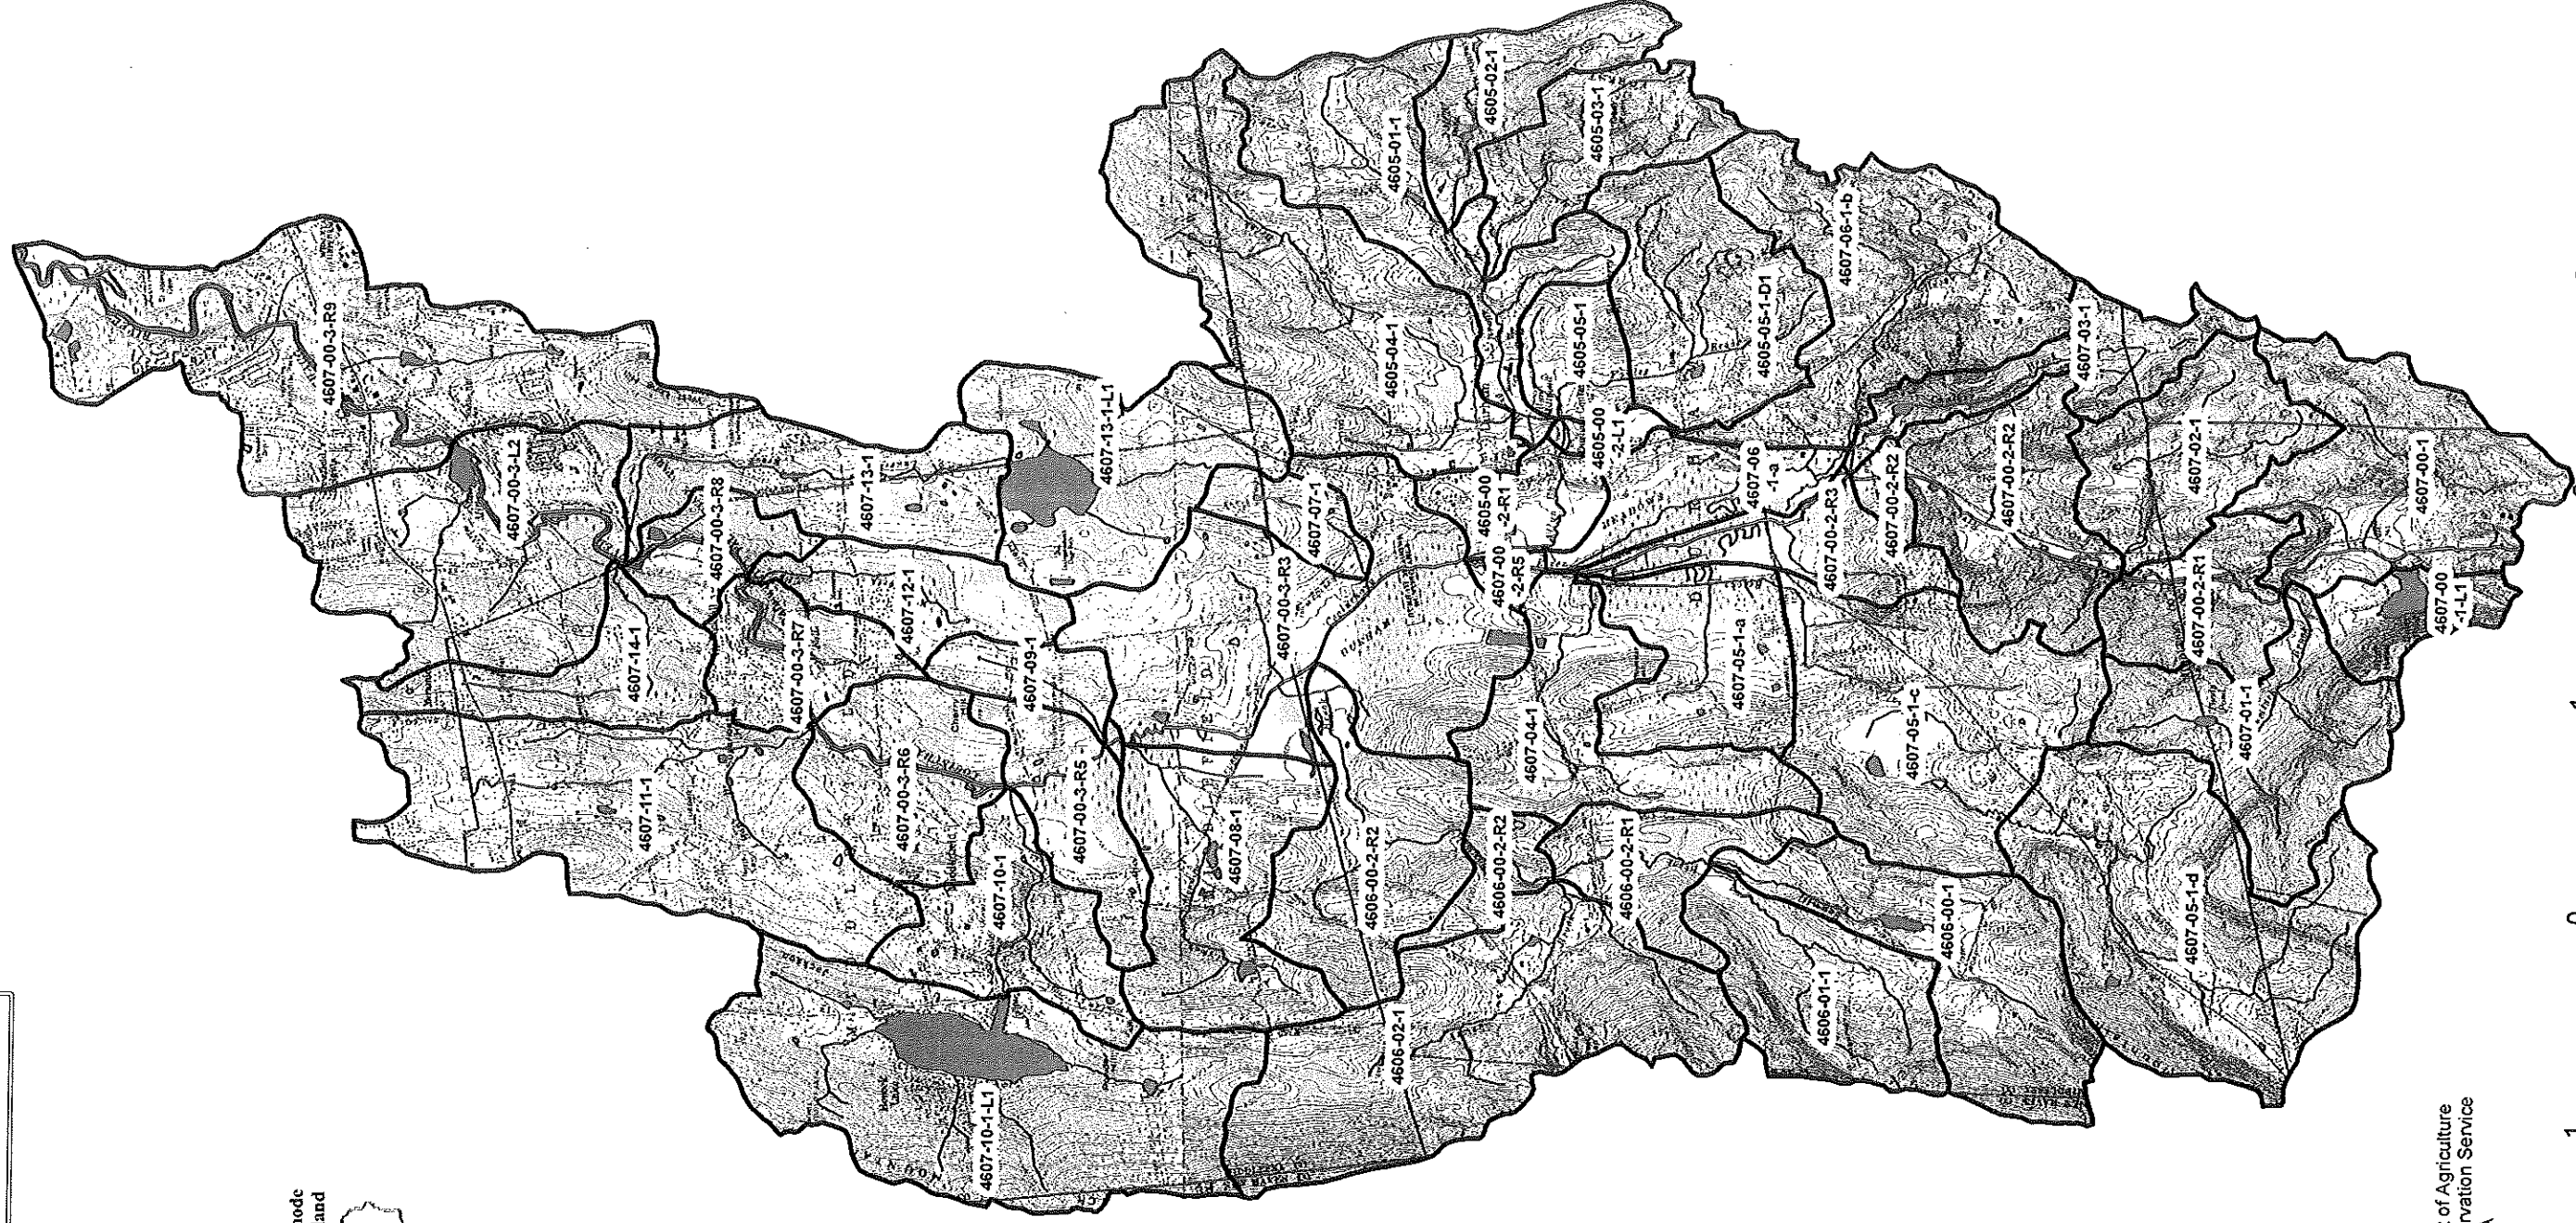
MAP 17: STREAMWALK SURVEY AREAS Coginchaug River Watershed

A streamwalk is a volunteer based assessment of the physical conditions of in-stream and streamside characteristics of the perennial streams within a river basin. It serves two purposes: resource evaluation through data collection and community involvement and education. The watershed was delineated into 33 survey areas (see Map 17: Streamwalk Survey Areas). The individual survey areas were selected by a trained volunteer team of two or more persons. The volunteer team was responsible for conducting the physical stream corridor assessment, gathering and recording their observations. The data gathered through the survey is a first step toward understanding the physical condition of a stream corridor. Although the streamwalk information may be used independently, using the data in

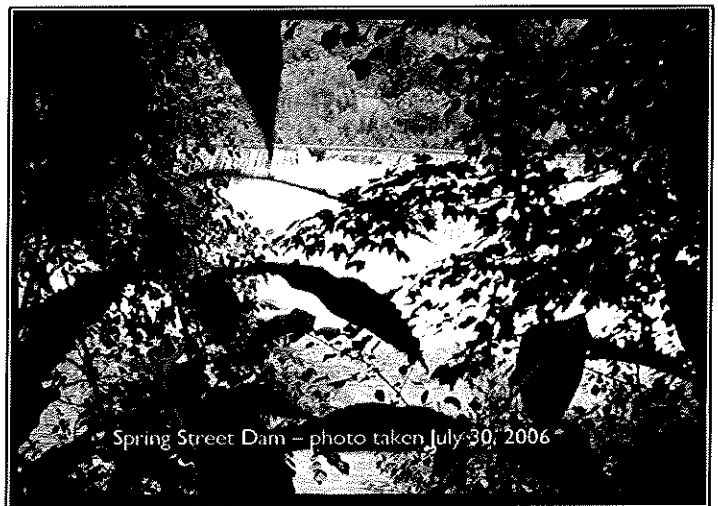
Spring Street Dam, the next upstream barrier, is located immediately upstream of Marszalek Park, a small open space are in the Town of Middletown, just south of Spring Street. This is approximately 0.77 miles upstream of Starnhill Pond Dam. NRCS was unable to obtain safe access to the site, and therefore the dam was viewed at a distance, and all measurements are estimates. Under current conditions, access to this run-of-river dam is

extremely limited; however, an access road from Marszalek Park could be constructed to facilitate the installation of a fishway. There is a sediment-filled eutrophic impoundment upstream of the dam.

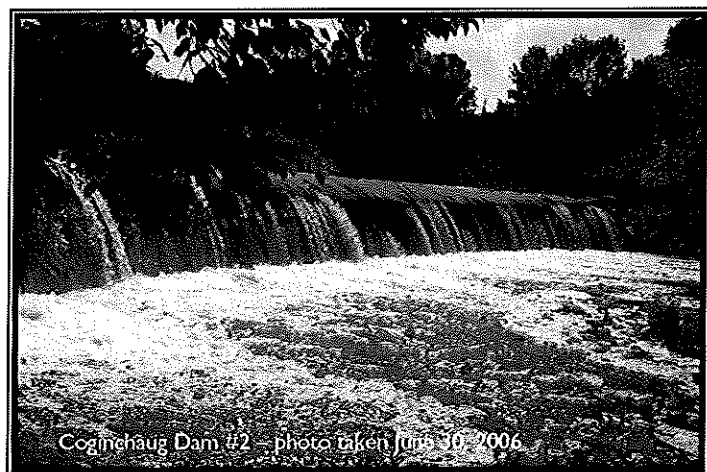
Located approximately 1.28 miles upstream from the Spring Street Dam, in the town of Middlefield, is another run-of-river dam, identified in the DEP dam inventory as "Coginchaug Dam #2". The site can be accessed through an industrial

site located immediately adjacent to the stream on the western streambank. The impoundment behind the dam is sediment filled and provides limited habitat for the targeted species.

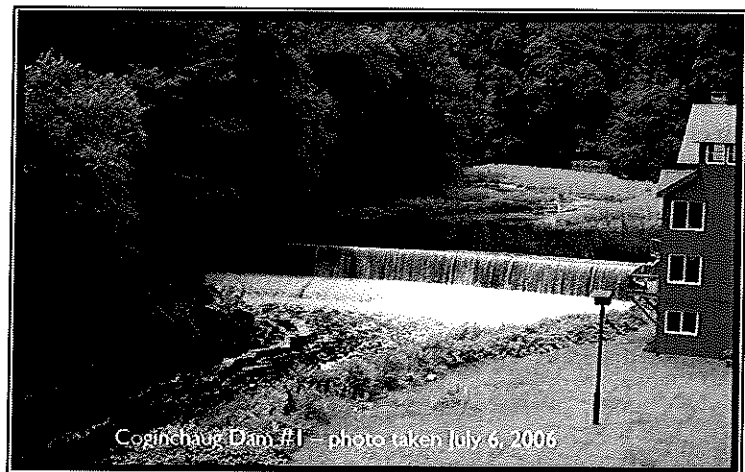
The fifth and final barrier, preventing the upstream migration of anadromous fish to the base of Wadsworth Falls, is located approximately 0.25 miles upstream of the Lower Wadsworth Falls Dam. Identified in the DEP dam inventory as “Coginchaug Dam #1”, this run-of-river dam has an old mill building on the left abutment, which appears to have been converted to a residential dwelling. The eutrophic impoundment has extensive sediment deposits, some of which extend above the elevation of the weir crest allowing for the establishment of emergent vegetation.

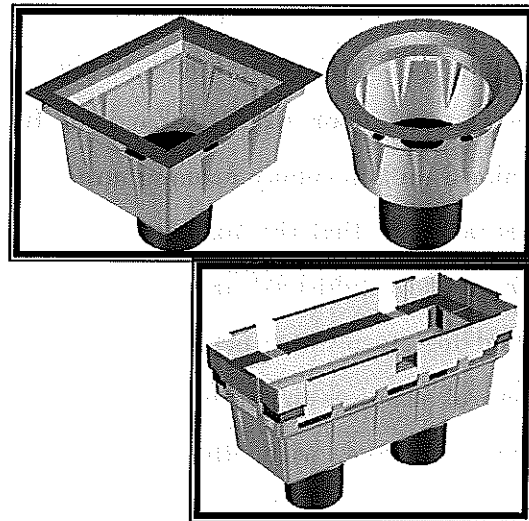
Images from www.transp.com

Catch basin inserts are devices installed in an existing catch basin, under the storm grate. The inserts treat stormwater through filtration, settling, or adsorption. A variety of manufacturers have commercially available products that are designed to remove a variety of pollutants, including bacteria, sediment, oil, litter and debris. Units need to be maintained routinely and filters need to be replaced on a regular basis to attain maximum removal efficiency. Replacement rates will depend on the type of pollutants being treated, the amount of
